Evaluation of C-C/SiC Pintle Anomalies in HT-6 Post-Test Photos

Randy Lee

Marshall Space Flight Center

March 2009

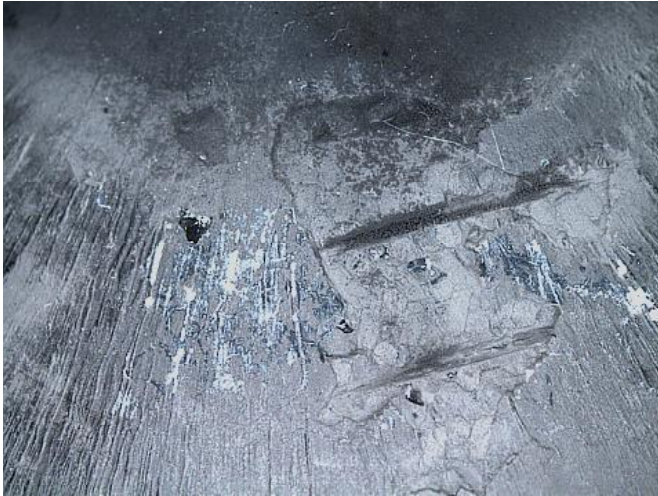
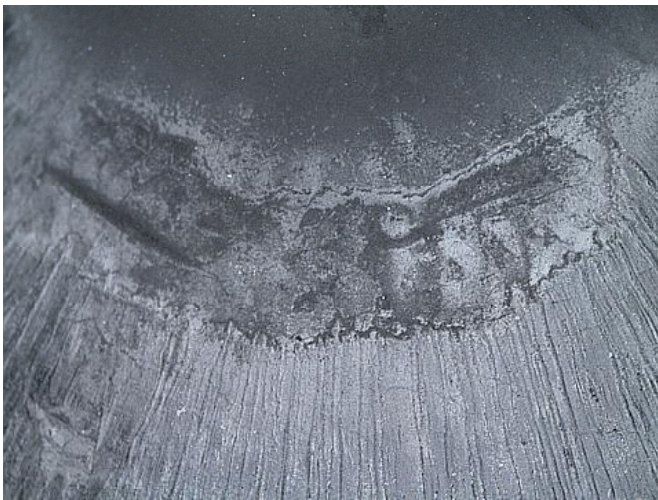
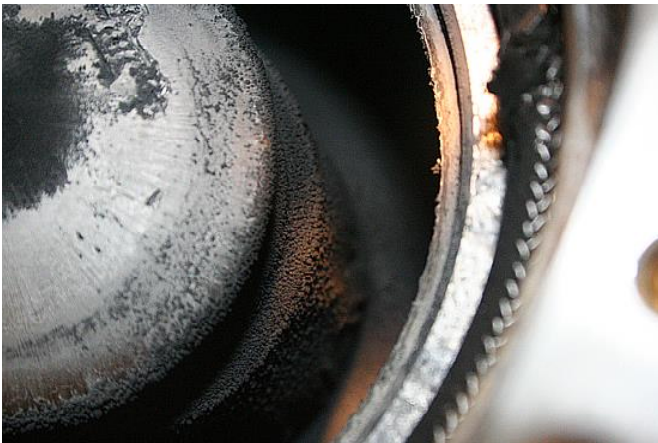
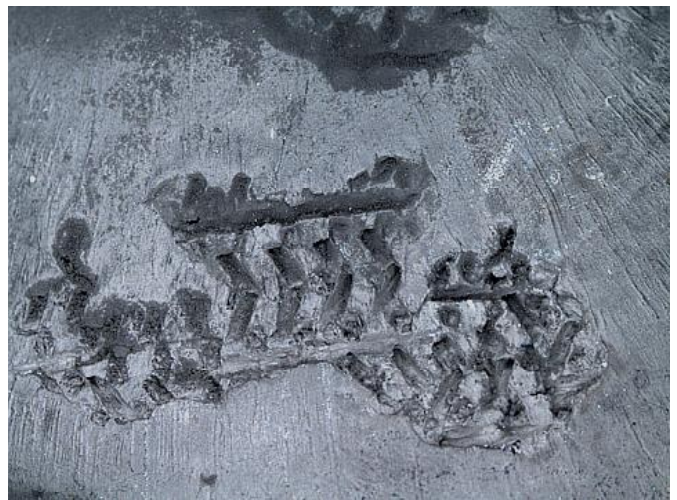
(1) Regions are seen in which the outer surface layer has spalled away, exposing the under-surface, or under layer (the seal coat appears to have debonded from the under layer or substrate surface). (2) Microcracks can be seen across the pintle surface on both the outer layer and under layer surfaces. In some areas of the exposed under layer, a hexagonal-type pattern is apparent. (3) Small areas of cooled molten metal have been deposited on both outer and lower layer surfaces (indicating that the metal was deposited after the coating spalled). (4) Short gouge-like indentions or trenche-like features are occasionally seen within the under layer surface, protruding downward into the substrate below the under layer. The indentation width is on the order of a fiber bundle diameter and is longitudinally oriented radially to the surface contour.

(5) Some of the spallations appear to have affected material below the level of the under layer, removing small sections of substrate matrix and/or fiber. The tire track effect is reflective of the n -D fibrous network comprising the structure of the substrate body. All images are looking down the z -axis (approximately)

The CTE mismatch between the substrate and Layer 1 is moderately significant. However, due to the freshly machined substrate surface, Layer 1 mechanical interlocks are so pervasive that the effects of the CTE differentials are subdued and Layer 1 is considered to remain strongly attached to the substrate during the burn cycle and the cool-down phase (as long as no other weakening factors are prevalent such as excessive closed porosity near the substrate periphery which can negate the mechanical interlocking effects). The CTE mismatch between the a-SiC-dominated Layer 1 and β -SiC rich Layer 2 may be as high as ~1.5-2 while the degree of mechanical interlocking connecting these two layers is insignificant. Thus, *the interface separating Layers 1 and 2 is the weakest interface in the system and appears to be the level where most of the spallations occur . . . during the burn cycle.* The particular areas or patches where spallations happen to occur are probably associated with material variations, some of which were alluded to earlier. Before the burn cycle ends, under layers which have been exposed due to spallation are susceptible to thermal crystallation.

If clusters of closed pores and/or large voids are present in the substrate just below Layer 1, a spallation event could become more extensive, possibly excavating sections of the substrate matrix in the process. Alternatively, if by chance some kind of debris grazed the surface of the pintle during the test cycle very close to a weakened porous area below, it is possible the impact damage could facilitate excavation, possibly extracting a small section of the material, and revealing the inner substrate structure underneath. In any case, clustered pores of this nature are uniquely prevalent in this particular C-C/SiC system and spallation/excavation of material could conceivably produce the apparent 'tire track' effect seen in one of the photos (this type of porosity is addressed below).

PIP cycles 11-13 leave a smooth, tightly adhered coating to the machined article surface but with minimal ‘fill and fare’ effects. Thus, a spallation event exposing Layer 1 might reveal these missing bundle segments as indentations or short trench-like depressions similar to those indicated in the photos. After all the outer PIP and Seal Coat layers have been applied and fired, these indentions are probably not even noticeable on the finished article. It is suspected that if Layers 4, 3 and 2 could be safely stripped from the surface, these kind of trench-like depressions could be seen periodically *all over* the surface of the articles. In other instances, some of the loosely bound bundle segments, which happen to stay on throughout the machining process, may ultimately dislodge and become liberated during an excavation/spallation event as the burn cycle takes place. These kind of impressions could contribute to the longitudinal trenches seen in the tire track pattern, where it almost appears as though the bundle segments were ripped out during the test process, perhaps late in the burn cycle or just as it ended.

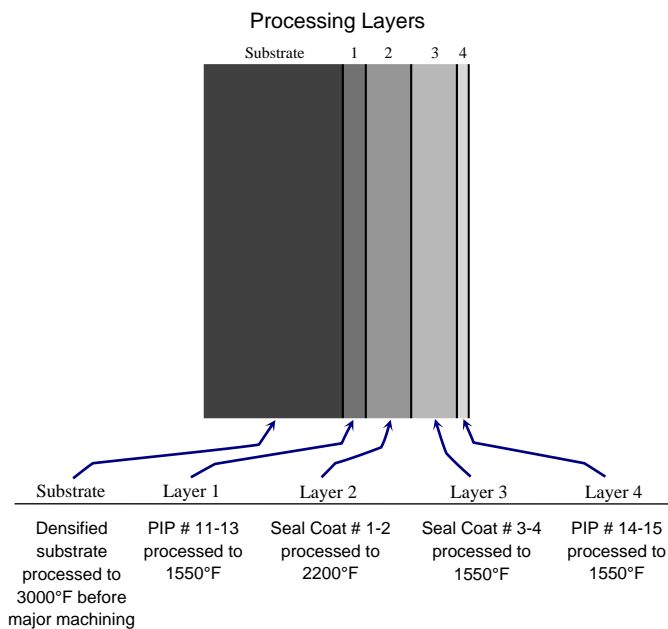
The accompanying figure (inferred from XYZ's indicated manufacturing flow) should help illustrate the various processing layers that generally exist on finished articles. However, caution is exercised since the *time-temperature profiles* utilized by XYZ during processing of each layer are unknown (these are usually company proprietary). Ideally, knowledge of the individual time-temperature profiles would be supplemented by also considering the cumulative effects of subsequent treatments on the under layers as each layer is sequentially applied and processed.

Thus, each PIP cycle and Seal Coat application deposits a layer of converted SMP-10 on the surface of the articles . . . but all the layers are not necessarily formulated or processed the same. Layer-to-layer differentials are expected in terms of layer thickness, degree of ceramicization, nature of adhesion to the adjacent layers and formulation make-up. Presumably, all articles undergo the same 1550F° rapid inert pyrolysis process (that is, there are no differences in the pyrolysis conditions, hardware, gas flow or gas composition). Thus, the primary difference between layers deposited via PIP impregnation and brush coating must be dependent on the specific properties achieved from each approach.

phases are known to be about 2.9-3.1 (g/cc) and 2.4-2.6 respectively (depending on the method of application and consolidation). Thus, both α and β -SiC > a-SiC, and for all practical purposes, both β -SiC and a-SiC are recognized as isotropic phases. On the other hand, the carbonized PAN fibrous reinforcement constituent in the substrate is highly orthotropic with a longitudinal CTE that is almost nil and a lateral or transverse CTE that is known to run somewhere in the 4-6 range (that is, the fibers get fatter while their lengths remain about the same). Thus, along directions parallel to the fiber bundle diameter, expansion/contraction effects of the reinforcement and SiC phase are comparable and compatible, but along longitudinal fiber directions, the β -SiC phase tends to expand and contract ~ 4 times greater than the fiber surface, so these interfaces are subjected to significant stresses during heat-up and cool-down events. As a matter of fact, longitudinal fiber-to-matrix interfaces represent the primary CTE mismatch within the C-C/SiC system. Thus, during thermal excursions, the following remarks can be made (reference the process layer diagram given earlier).

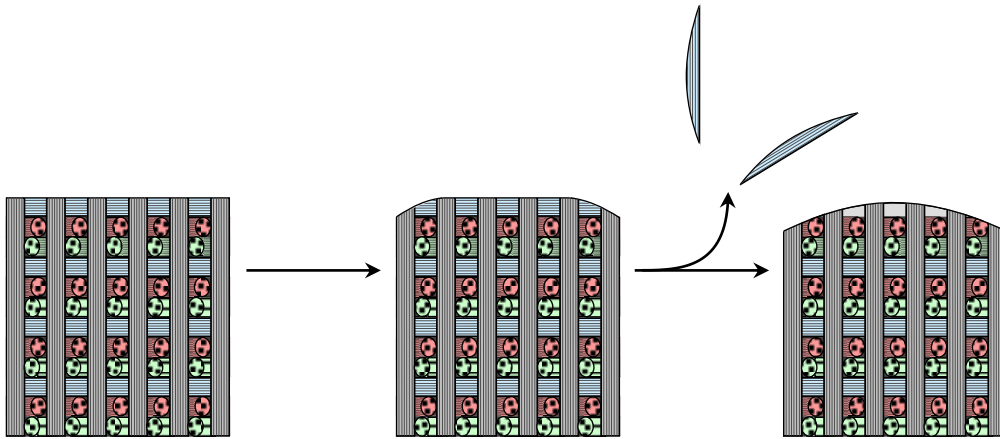
comprising the lateral reinforcement. Consequently, $u-v-w$ bundles located closest to the pintle shaft circumference edges, as well as those local to the pintle head apex, become the shortest bundle segments within the entire body. The value of these shortened bundle segments (or bundle stubs) to the overall composite integrity is questionable. More importantly however, they are most vulnerable to extraneous forces, excessive localized porosity and excavation effects. It is certainly conceivable that some of these shortened, outer bundle segments would be susceptible to machining agitation and could possibly be loosened or dislodged during the machining process. Additionally, the presence of intersection voids and localized porosity surrounding some of these bundle segments reduces the fiber-to-matrix bonding contact area and increases the likelihood of extraction.
