Reinforced Carbon-Carbon (RCC)

Leading Edge Structural Subsystem (LESS)

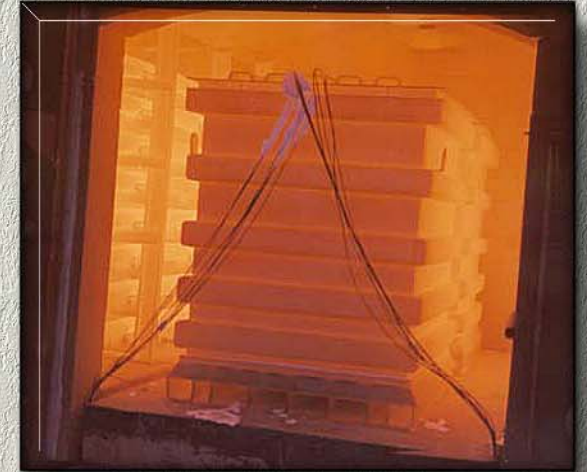
Pyrolysis restraint fixturing;
Impregnation chamber in background

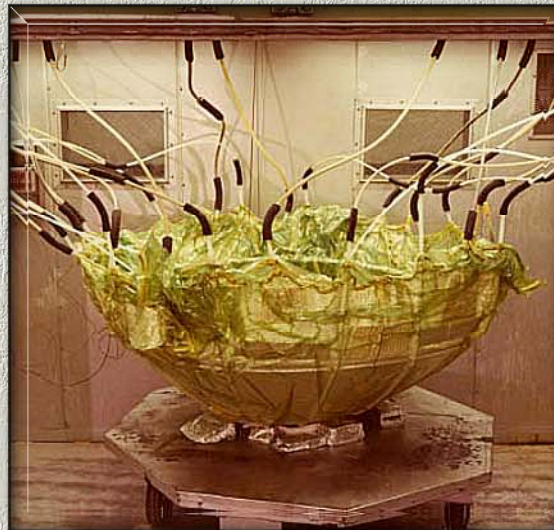
TEOS impregnation underway

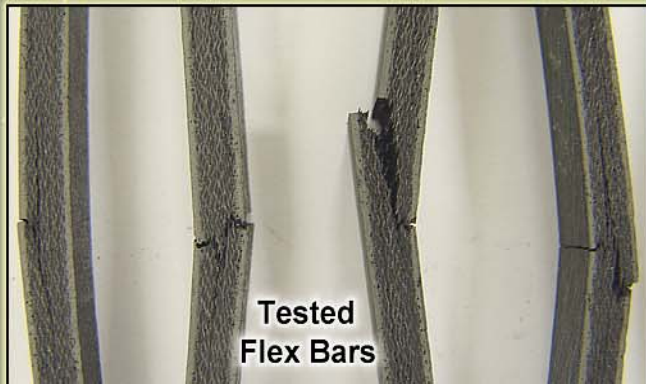
Tested Flex Bars

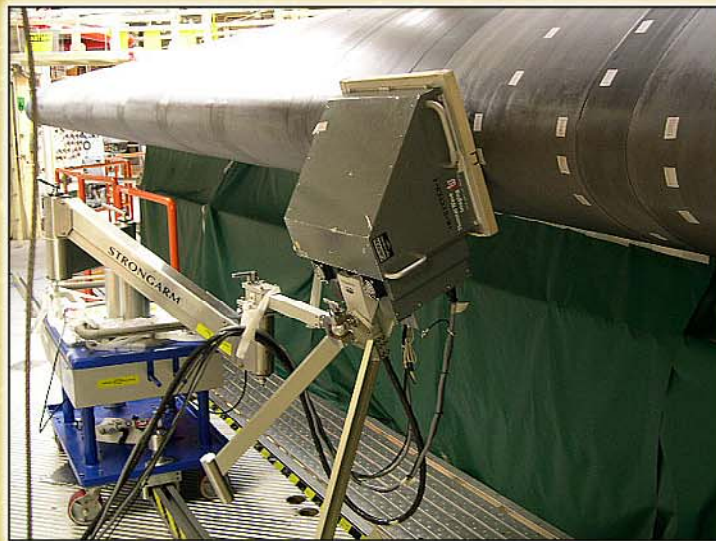
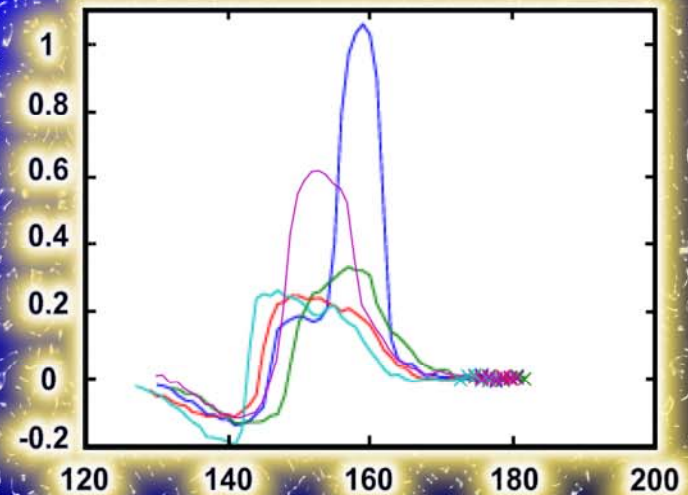
- **Flash IR Thermography NDE technique being refined to identify pass/fail criteria and material property correlations**
- **Minimum 0.2 IR indication proposed by NESC; Tiger Team decisions based on flight-to-flight delta**
